HUNGARIAN ATOMIC ENERGY AUTHORITY Nuclear Safety Bulletin

RECENT DEVELOPMENTS IN NUCLEAR SAFETY IN HUNGARY

November 2013

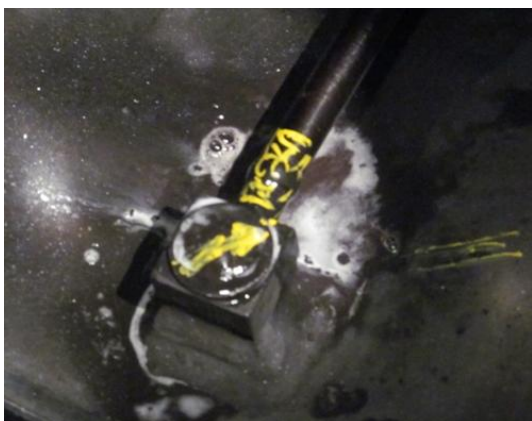
On the 6th of June 2013, a pressure rise was noticed by the operating personnel on nitrogen pressure gauge of the weld protection chamber of steam generator 4 (SG4). The pressure was released and sampling was taken from the weld protection chamber according to the procedures. The sample showed the presence of fluid. Results of chemical analysis of the

Leak location at welded joint between the nozzle and the nitrogen line

sample confirmed that the origin of the fluid was not the primary side. After multiple samplings the secondary side leak was clearly identified, and gradual shutdown of the unit was initiated as required by the Technical Specifications (TS). The appropriate inspections have been performed in cold state of the unit, which determined that the leak had been caused by a weld defect on the

nitrogen charging line of the weld protection chamber, which is drained into the secondary side of the steam generator. After weld repair and

The material testing identified that the nitrogen charging line of SG4 weld protection chamber leaked at the dissimilar weld between the nozzle and the main body was, which fault was caused by galvanic corrosion. The affected line was previously not included in the material testing and ageing management programmes.

successful leak test of the protection chamber, the unit was started up and power ascension to rated level was performed.
