REGULATORY  
ASSESSMENT OF THE  
HUNGARIAN  
NUCLEAR FACILITIES  
AND RADIOACTIVE  
WASTE  
REPOSITORIES IN  
2016

Hungarian Atomic Energy Authority

**August 2017**

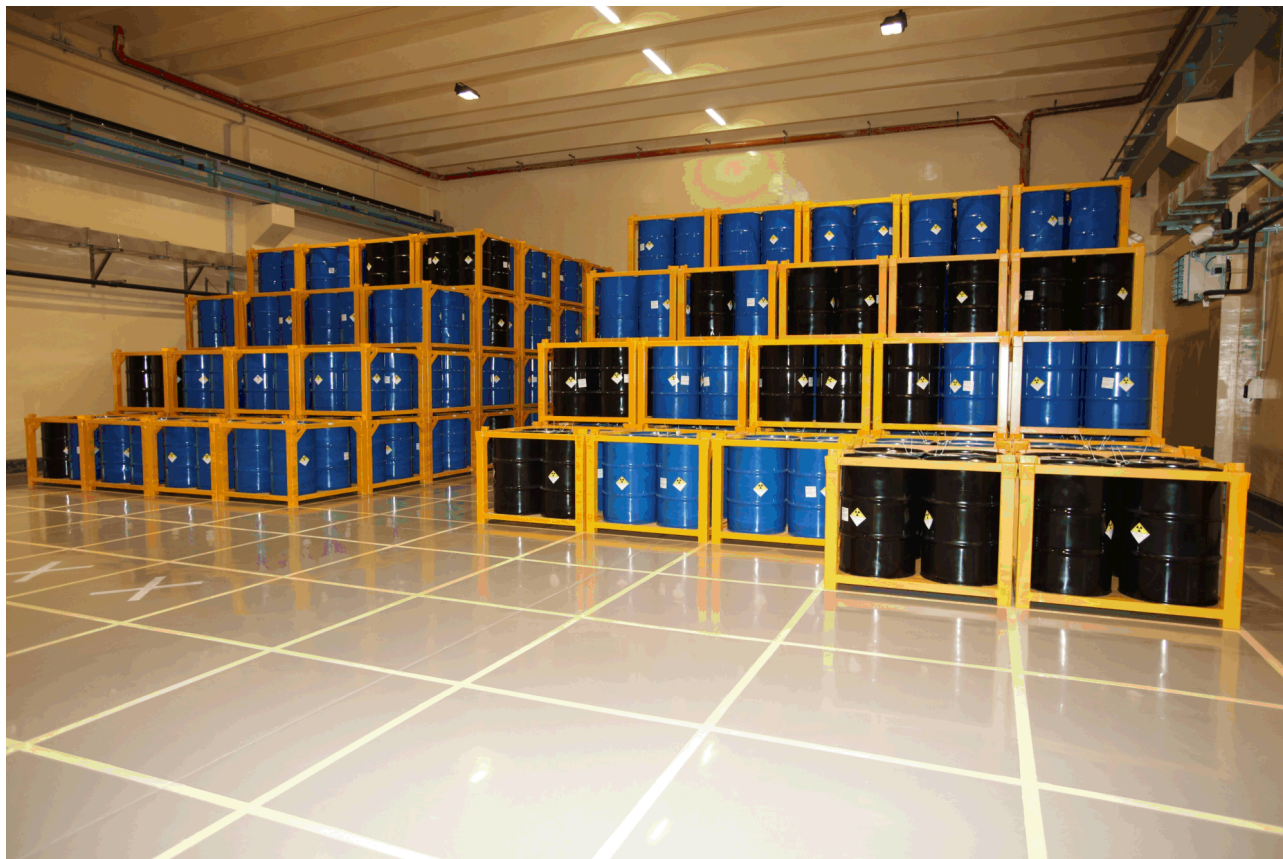
Figure 2.5-1: Operation hall of the technology building (Source: <http://www.rhk.hu/images/sajto/nrht-felszin-technologiai-epulet-uzemcsarnok.jpg>)

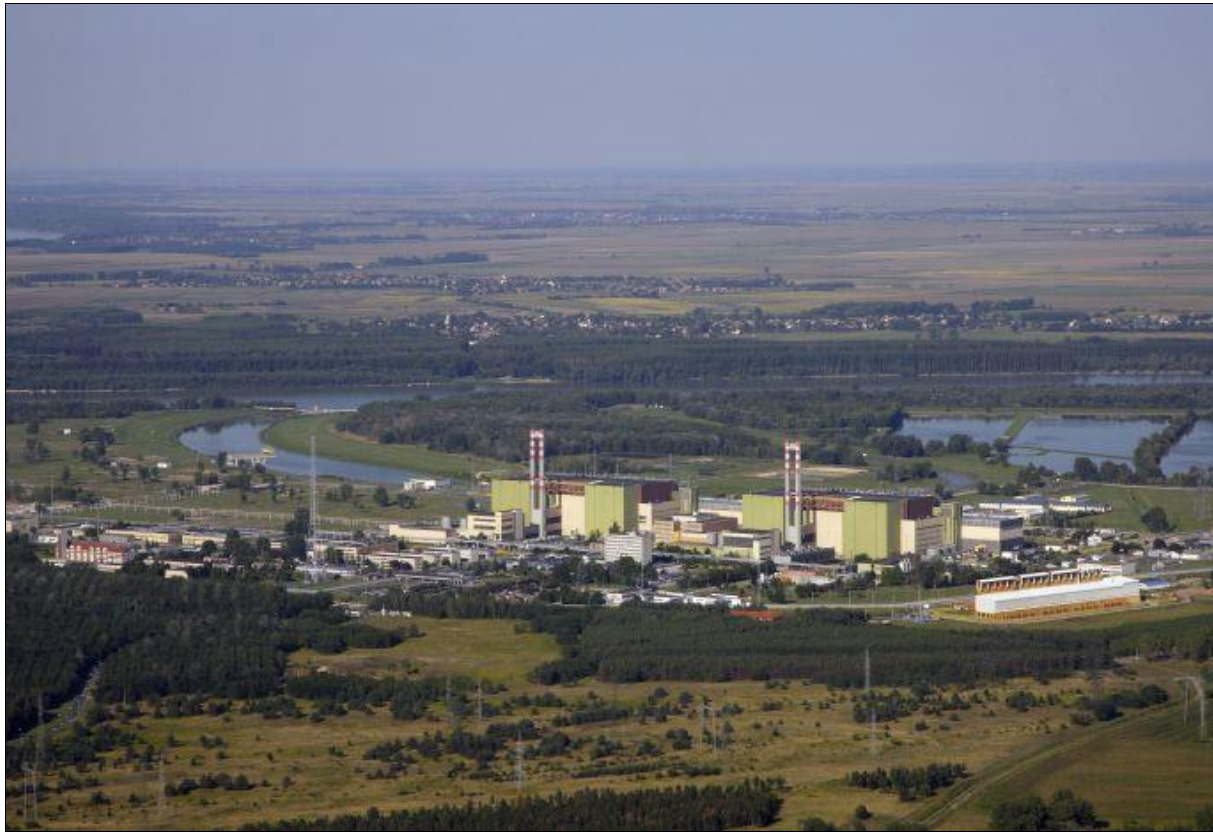
MVM Paks Nuclear Power Plant (Source: [www.atomeromu.hu](http://www.atomeromu.hu))

Unit	Power	Start of operation	Type	Site	Internet site
Unit 1 PAE1	500 MW	1983	VVER-440/213	Paks	<a href="http://www.atomeromu.hu">www.atomeromu.hu</a>
Unit 2 PAE2	500 MW	1984	VVER-440/213		
Unit 3 PAE3	500 MW	1986	VVER-440/213		
Unit 4 PAE4	500 MW	1987	VVER-440/213

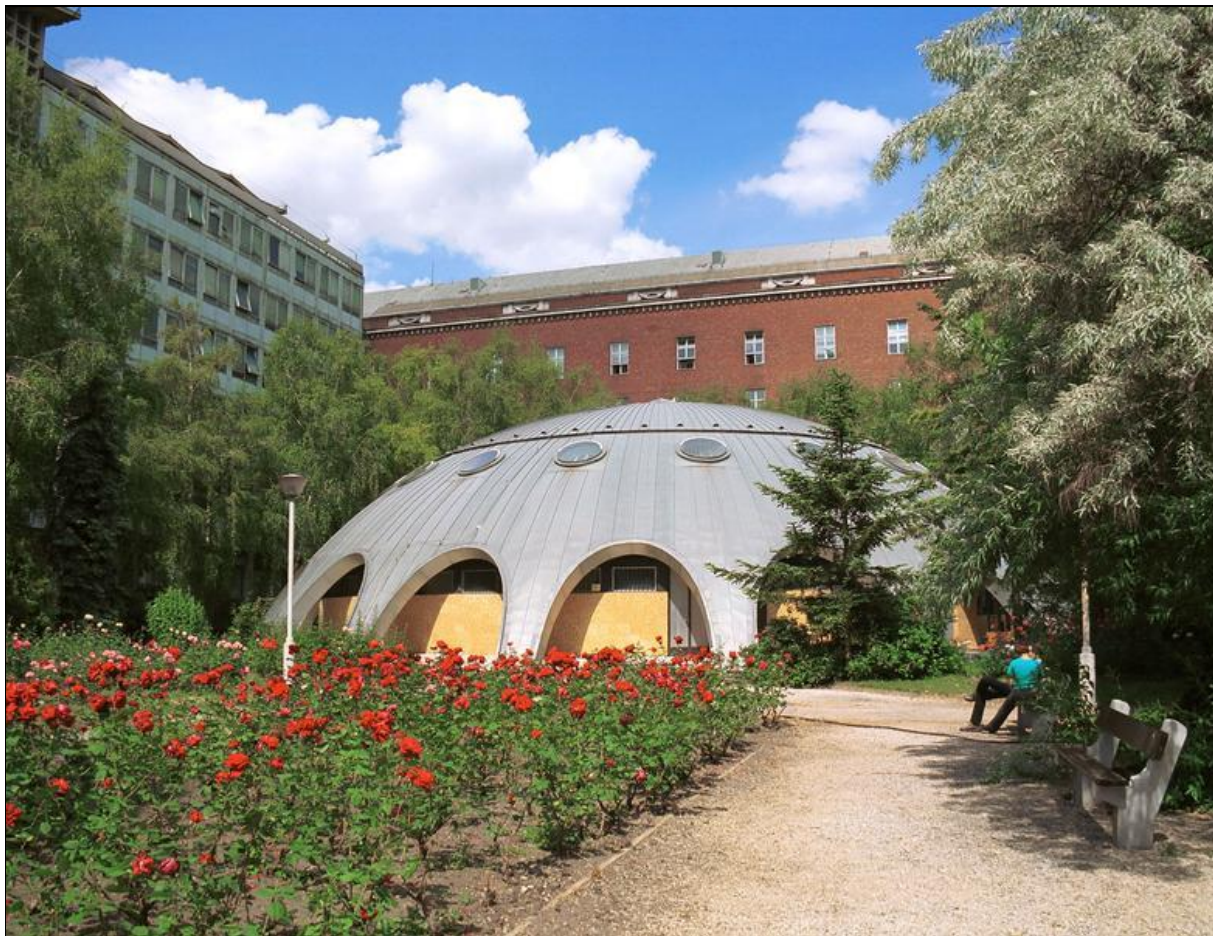
Training Reactor (Source: [www.reak.bme.hu](http://www.reak.bme.hu))

Type	Power	Start of operation	Site	Internet site
Pool type	100kW	1971	Budapest District XI. Műgyetem quay	<a href="http://www.reak.bme.hu">www.reak.bme.hu</a>

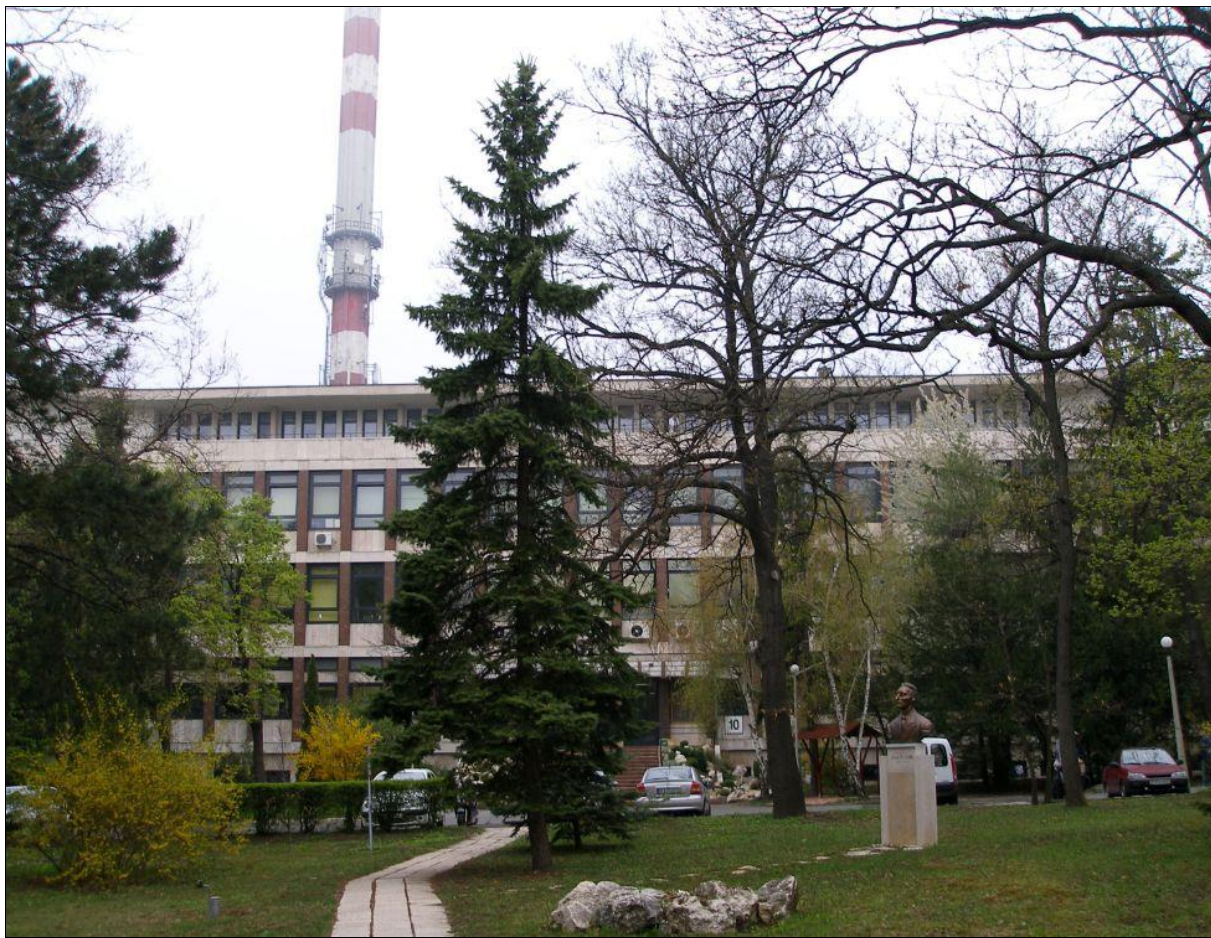
Budapest Research Reactor (Source: [www.bnc.hu](http://www.bnc.hu))

Type	Power	Start of operation	Site	Internet site
Tank type	10 MW	1959	Budapest, District XII	<a href="http://energia.mta.hu/hu">http://energia.mta.hu/hu</a>
