REGULATORY
EVALUATION OF THE
HUNGARIAN
NUCLEAR FACILITIES
AND RADIOACTIVE
WASTE
REPOSITORIES IN
2018

Hungarian Atomic Energy Authority

August 2019

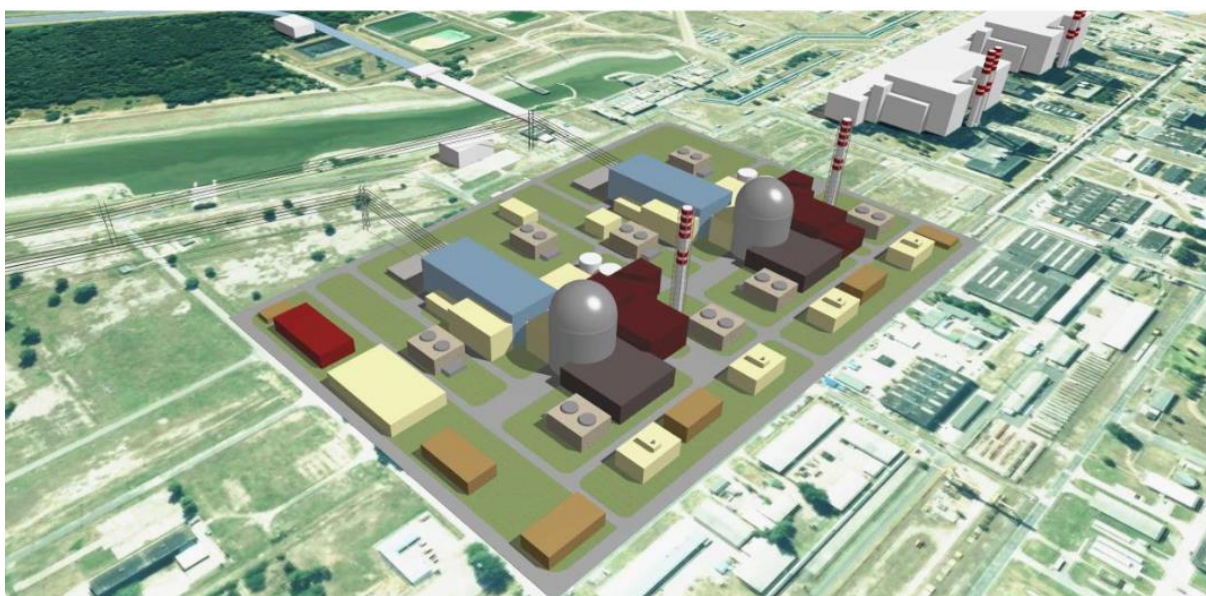
Figure 2.7-1: Design view of the new units (Source: <http://www.mvmpaks2.hu/>)

The Paks II. Ltd. is a project company established for the construction of new nuclear power plant units. It became a licensee of the HAEA after the site survey and assessment license was granted to it in 2014. Subsequently, it also obtained the site licence in 2017. Currently the preparation of plans of the new nuclear power plant and its Preliminary Safety Analysis Report is in progress with the involvement of the Russian principal contractor. The next step of Paks II. Ltd. will be the submission of the Construction License Application.

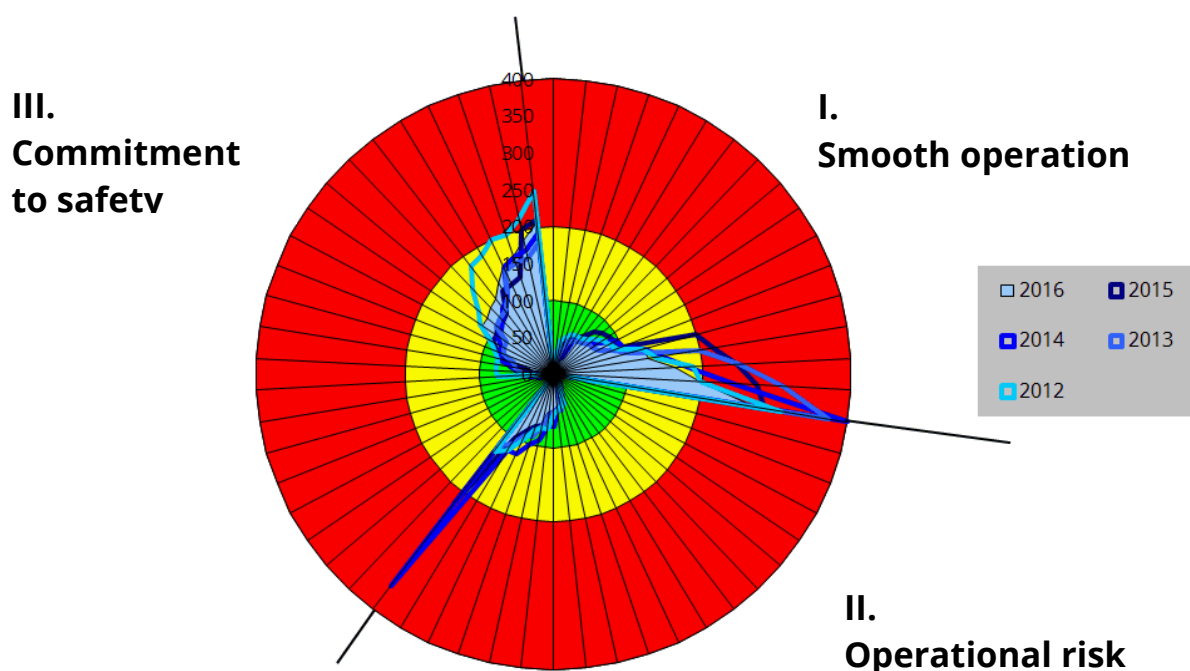
Figure I.2-1: SPI circle diagram

The change of the safety performance level is shown in a circle diagram (see Figure I.1-2). The diagram shows the numeric values of safety attributes in a relative scale, where the values of the attributes are represented in increasing order, in percentage of the criteria specified in the different fields. The three sectors represent the three safety areas, the three levels of evaluation range are represented by the green circle, and the yellow and red rings. The area contained by the values represents the general summary of the safety performance for a given period of time. It provides an overview of the problematic sub-areas identified by the SPIS and the timely evolution of safety performance. The change of each area in time can be well followed based on the envelope of the values of the safety attributes.
